Measuring external PICC Length

Critical Misuse: Gauze Under the Line

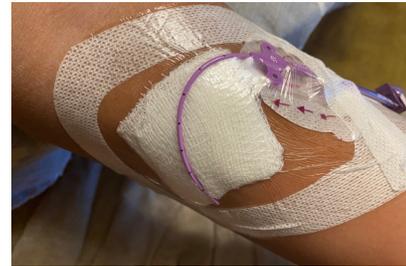
Changing a PICC line dressing requires several skills including strict adherence to Aseptic No Touch Technique (ANTT), the ability to assess for site complications including catheter dislodgement, and an understanding of the evidence-based standards that guide appropriate procedure for dressing changes. One critical mistake that is frequently made by nurses performing PICC dressing changes is the use of a gauze 2x2 underneath or over the PICC line contained under the transparent dressing. According to the 2021 Infusion Therapy Standards of Practice:

Sterile gauze dressing should be used primarily for excessive moisture in the form of site drainage or diaphoresis. Secondly, gauze may be used to support the vascular access device but should not be positioned in a way that obscures the insertion site.

1. When gauze obscures the insertion site, assessing for phlebitis, infection, or PICC dislodgement may be impossible. For this reason, gauze dressings should be removed every 48 hours at minimum to allow for comprehensive site assessment.
2. When gauze is used under the PICC, the transparent dressing adheres to the gauze, sandwiching the PICC line between the dressing and the gauze. It is nearly IMPOSSIBLE to peel the dressing off the gauze without PULLING OUT THE PICC LINE. If you MUST put gauze under the PICC due to drainage or skin breakdown, please place another piece of gauze over the PICC, sandwiching the PICC between two pieces of gauze before applying the transparent dressing. Using this technique will keep the adhesive dressing from adhering to the bottom layer of gauze, making it easier to remove.
